| Bulletin # | SR - 5H - 903 |

SAFETY ALERT

| Ride Manufacturer | Frank Hrubetz & Co., Inc. Killinski Mfg. Company Man-Co Mfg., Inc. | Affected Production Dates | 1973 until 1991 |
| Ride Name | Hurricane | Affected Serial #'s | All |

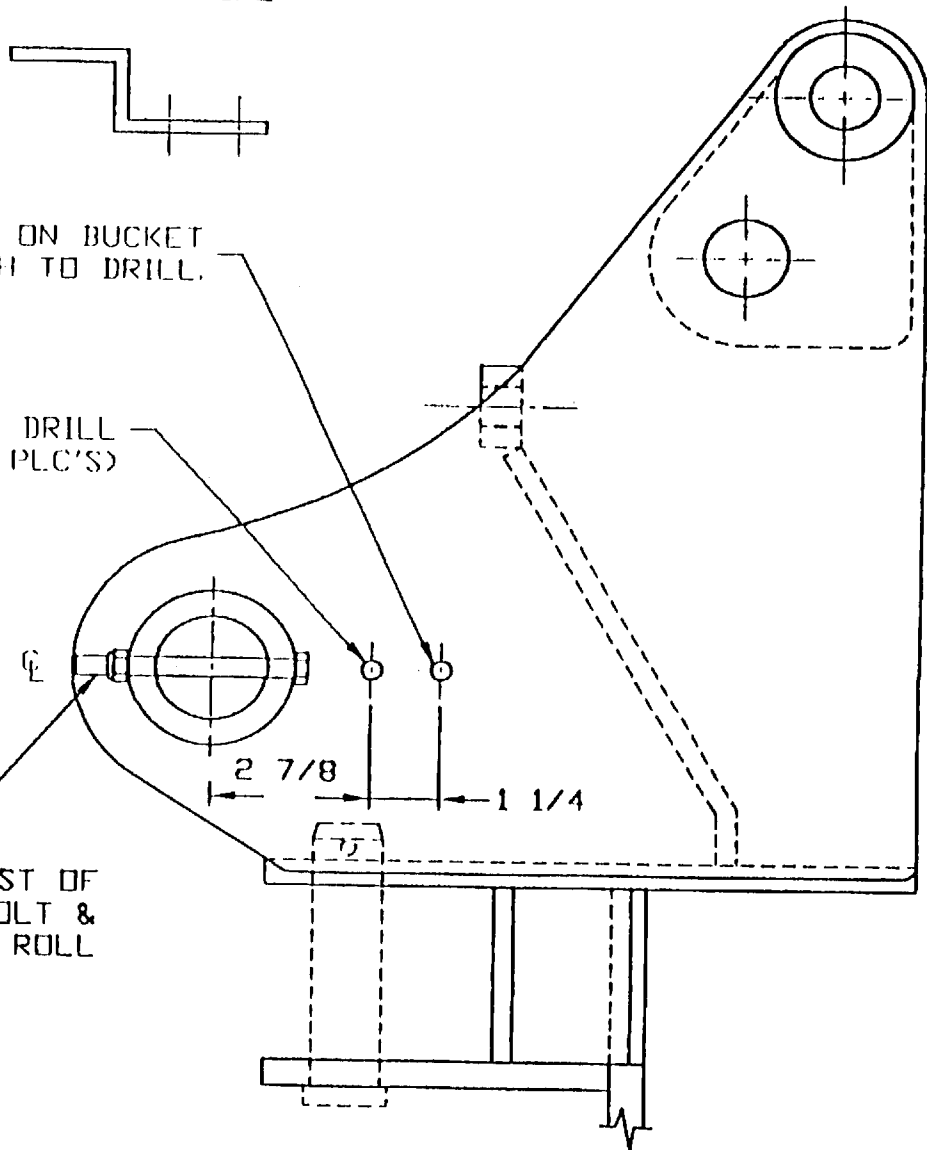
Inspection Before implementing the changes explained below remove the cars from the sweeps. Locate the grease Zerk on the end of the Sweep. Add lubrication to this zerk until the cavity is full. Inspect the bolt or roll pin shown as item 20 on Page 2. If a bolt is found be sure the bolt is a grade 8. Inspect to be sure that it is not damaged and capable of maintaining the pin in its bore and prohibiting the pin from rotating. Replace with a 3/8 NC x 4" grade 8 bolt and grade 8 nyloc nut if any damage is found. Car buckets must also rotate freely in relation to the sweep, indicating that the bushings in the sweep end are not binding on the shaft. Keeper bolt orientation must be as shown on Page 2 in order to clear pin retainer.

ITEM #20 CONSIST OF
3/8 GRADE 8 BOLT &
NYLOCK NUT OR ROLL
PIN.

Page 2 shows the pin retainers that must be bolted to both sides of the car buckets that are attached to the end of the sweeps on all Hurricanes. With the pin retainers in place the shaft will be retained in position in the sweep even without the proper functioning of the pin locating bolt. Using an electric drill, drill one hole in both sides of the sweep bucket. The location of these holes is shown in Page 2 at 2 7/8". Bolt the pin retainer on with one bolt so that the tab of the retainer covers the end of the bucket pin. Now use the retainer as a jig to drill through for the lineup of the second 3/8 hole. Bolt the retainer in place using grade 8 bolts, grade 8 nyloc nuts and flat washers as called out in the material list on page 2. Insert the bolt from the inside to the outside of the bucket. Place the nyloc nut on the outside face of the bucket so it can be easily inspected. Torque to 40 ft. lbs. The flat washers are located under the bolt head and under the Nyloc nut.

POSITION ITEM 16 ON BUCKET
& CENTER PUNCH TO DRILL.

13/32 DRILL
(2 PLC'S)
