Safety Alert

Re: Sweep failure incident in Puerto Rico.

Safety Bulletin

Bulletin No: SOSA005

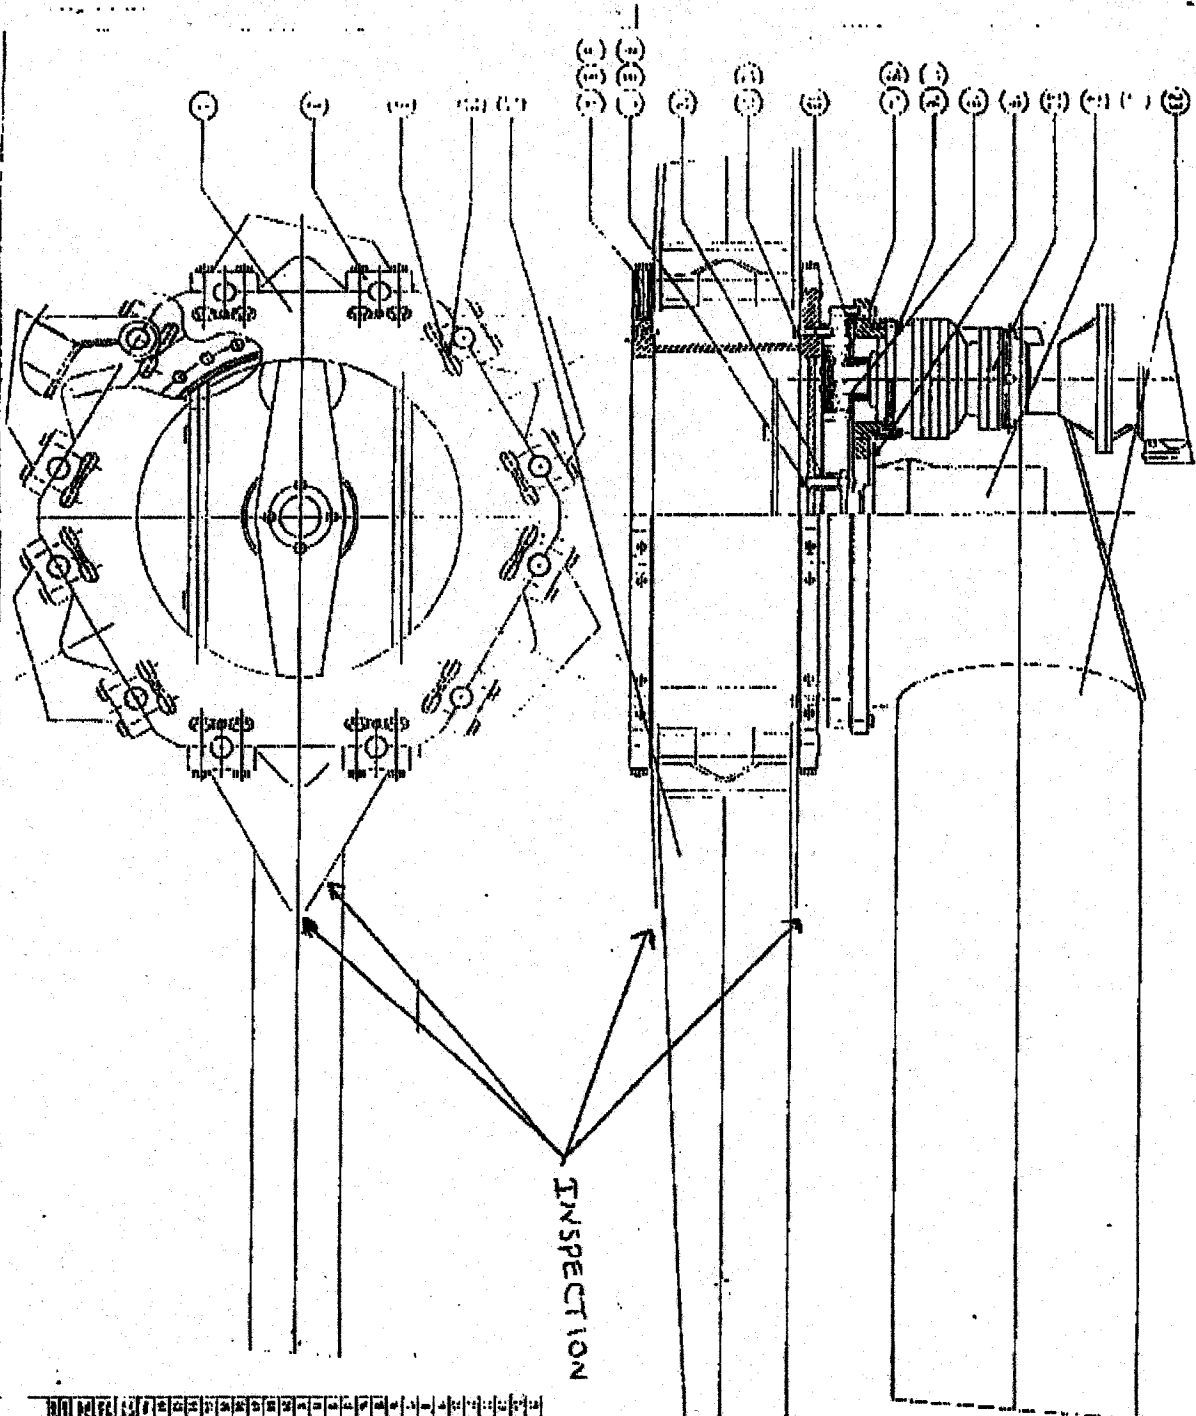
INSPECTION AREA

It has come to the attention of Tivoli Mfg. Ltd. from the original designers of the Spin Out, KMG Europe BV, that there has been cases where cracks have been detected on the sweep arms (see attached drawings) of Spin Out rides operating in Europe.

Tivoli Mfg. Ltd requires that all operators inspect the areas indicated on the attached drawings. If cracking is detected please report to AmTech / Amusement tech. intl. Inc. at 817-641-5045 for repair procedures and gusset kits.

If no cracks are detected as described in the attached drawing, a monthly inspection of this area of the sweeps should added to your existing inspection procedures.

If required, gusset plates will be made available free of charge and can be ordered through Amtech / Amusement Technologies Int'l. Inc.
