SERVICE BULLITIN:

RE: HIGHFLYER 1:

RE: LAP BAR PAWLS

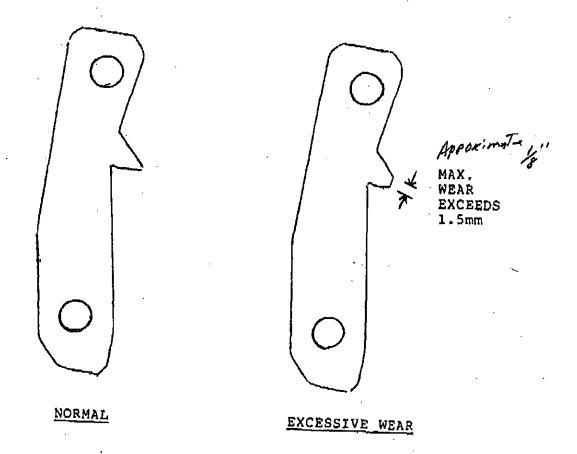
SIDE VIEW OF PAWL

THIS IS TO INFORM SKYMASTER AND HIGHFLYER OWNERS THAT THE PRACTICE OF LOADING OF PASSENGERS WITH THE LAP BARS IN THE "UP" POSITION, AND THE "LOCKED" POSITION, WILL SPEED UP THE NORMAL WEAR & TEAR OF THE PAWL TOOTH.

WHEN A PASSENGER IS LOADED AND PULLS THE LAP BAR DOWN, AND IT RATCHETS, WE HAVE FOUND WILL EXPEDITE THE PAWLS NORMAL WEAR.

Directors: M. Steffens, S. Steffens V.A.T. No. 348-3613-46 Registered in England No. 1534898 CHECK LAP BAR PAWL TIP FOR WEAR AND DEFECTS.

MAXIMUM TIP WIDTH NOT TO EXCEED 1.5mm.

WE RECOMMEND LOADING OF THE RIDE, THEN ALL LAP BARS BE PULLED DOWN BEFORE LAP BARS ARE "LOCKED" AND THEN CONFIRMED ALL ARE SECURE BY THE OPERATOR.

PAWLS SHOULD BE CHECKED, AT THIS TIME, FOR WEAR & TEAR AS IN THE ENCLOSED DRAWING.

IF WEAR EXCEEDS THIS AMOUNT THEN REPLACE WITH A NEW FACTORY UNIT.
