Mega Coaster NITRO

Six Flags Great Adventure

LIST OF MANUFACTURER'S NOTICES

Roller Coaster : **Mega Coaster Nitro**

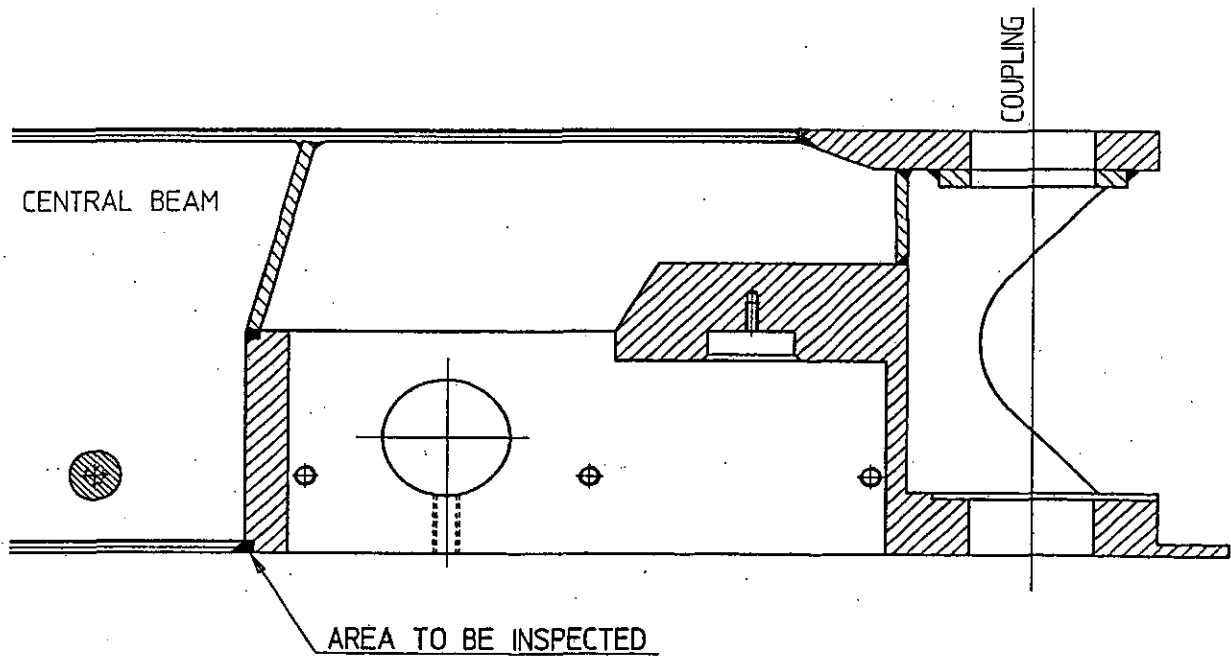
- 1) We draw your attention to the fact that cracks were found at the connection ratchet box / plate on the central beam of the coaches on one B&M ride.

- 2) We accordingly ask you to inspect these connections as follows:
 - a) immediate visual inspection, then
 - b) weekly visual inspection.

- 3) If any crack is found, the crack needs to be repaired before being further operated.

Bolliger & Mabillard shall be informed of any such crack.

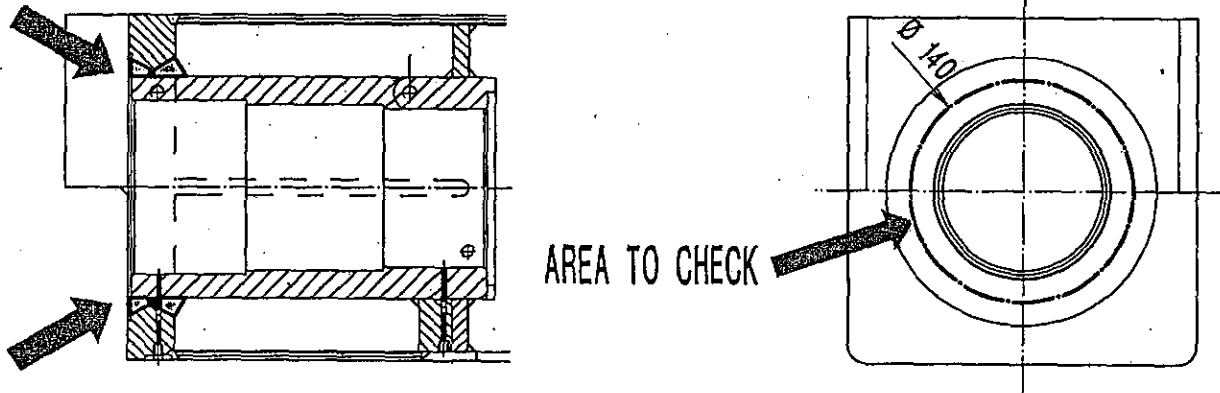
1. We draw your attention to the fact that one crack was found in the weld between the front plate of the central beam and the pipe of the coupling receiver on a B&M coaster.

THE AREA SHOWN ABOVE SHALL BE INSPECTED AT LEAST ONCE A YEAR AS FOLLOWS:

- a) dismantle the fork and the front thrust washer on each vehicle.
- b) magnetic particle inspection of the area shown above.

Bolliger & Mabillard shall be informed of any crack found. Vehicles presenting cracks shall not be operated.
