SAFETY ALERT

Ride Manufacturer: Majestic Manufacturing	Affected Production Dates: All Production Dates
Ride Name: Musik Express	Affected Serial Nos.: All Serial Numbers
Model Number: All Model Numbers

Abstract of Issue:
 Musik Express spreader ears have become damaged or worn beyond acceptable tolerances for operation.

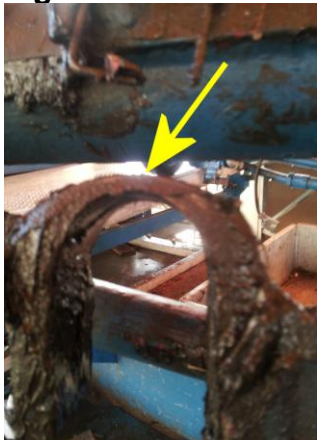
Detail Of Issue:
 Figure 1:

Reason For Release:
 The reason for this safety alert is to notify all inspectors, owners and, operators of a safety concern with the Musik Express spreader ears. We have found that over time the Musik Express spreader ears can become damaged or worn beyond acceptable tolerances for operation. This can be caused by the Musik Express spreader ear bushings are worn or the spreader ear bushings are not present.

This is a picture of a Musik Express spreader ear that is damaged and worn beyond acceptable tolerances.

Action To Be Taken:
 All Musik Express amusement rides should be inspected for damaged or worn spreaders ears that are beyond acceptable tolerances for operation. Any Musik Express amusement rides that are found with damaged or worn spreaders ears that are beyond the acceptable tolerances must be replaced before operation.

The lowest acceptable tolerance for the material thickness for the Musik Express spreader ears is 85% of the original material thickness.
