Urgent Defect Notice

Date: 08.02.2011.

Device: Huss - Enterprise.

Defect: Cracking near the upper ram attachment area.

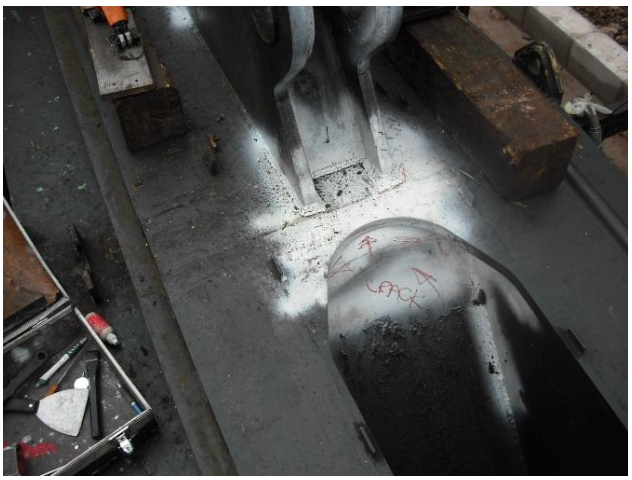
The defect has now been found on two enterprise devices. The cracking is located below the upper ram attachment area and under the main boom plate. Both areas of cracking that have been found are between 370mm - 390mm long and were both found visually and then subjected to MPI to establish the full length of the crack.

One of the devices was inspected with the ram removed and the other with the ram in place; on both devices the cracking was easily found.
