SHOULDER HARNESSSES MECHANISM

We have been informed that a SPRING RIDE owner experienced the following situation on the SHOULDER HARNESSSES mechanism:

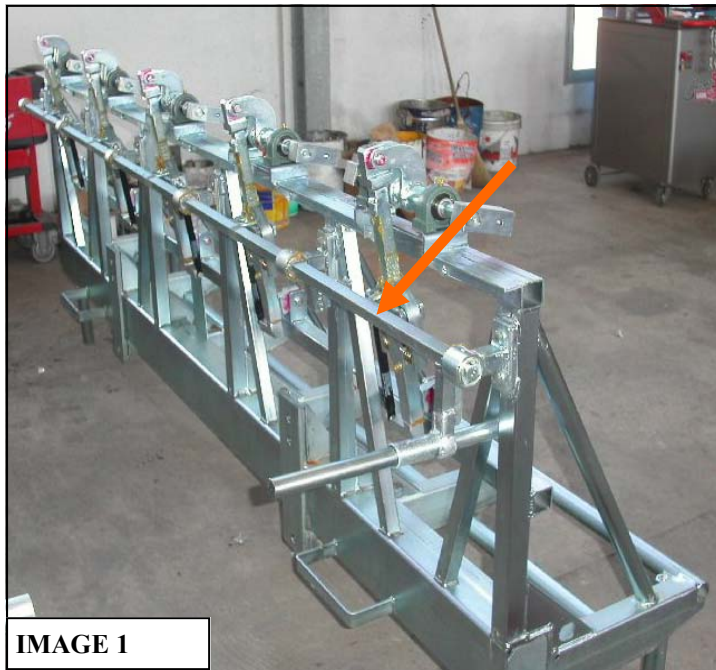
IMAGE 1

1 DISMANTLE THE RELEASE BAR

3 RE-INSTALLED THE BAR AND CHECK AGAIN (IMAGE 1)
