NUMBER: B400R1054-0

SERVICE BULLETIN

Ride: GIANT GONDOLA WHEEL

Subject: Tie Rod Installation

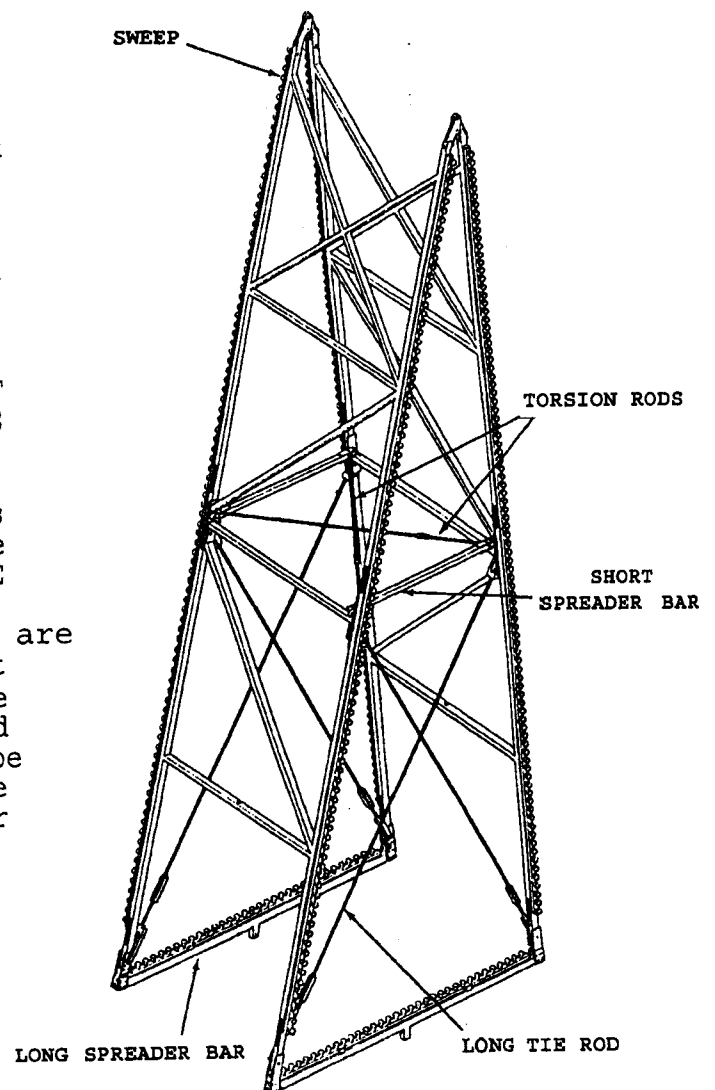
CHANCE RIDES, INC. has received a report of a GIANT GONDOLA WHEEL ride which was operated without first installing the long tie rods and torsion rods. This could have resulted in serious structural damage to the ride and possible injury to passengers and bystanders.

Always install these parts exactly as described in the set-up portion of the CHANCE OPERATION & MAINTENANCE MANUAL. The tie rods and torsion rods are necessary to maintain the correct shape and alignment of the wheel. All maintenance and set-up personnel must be instructed as to the importance of these parts and their proper installation.

NEVER OPERATE THE RIDE WITHOUT THE TIE RODS AND TORSION RODS PROPERLY INSTALLED.
